XT413-R935

## TECHNICAL BULLETIN

Turn Signal Indicator –  
Replace GECM –  
RECALL R935

MODEL 2002-03 MY  
X-TYPE

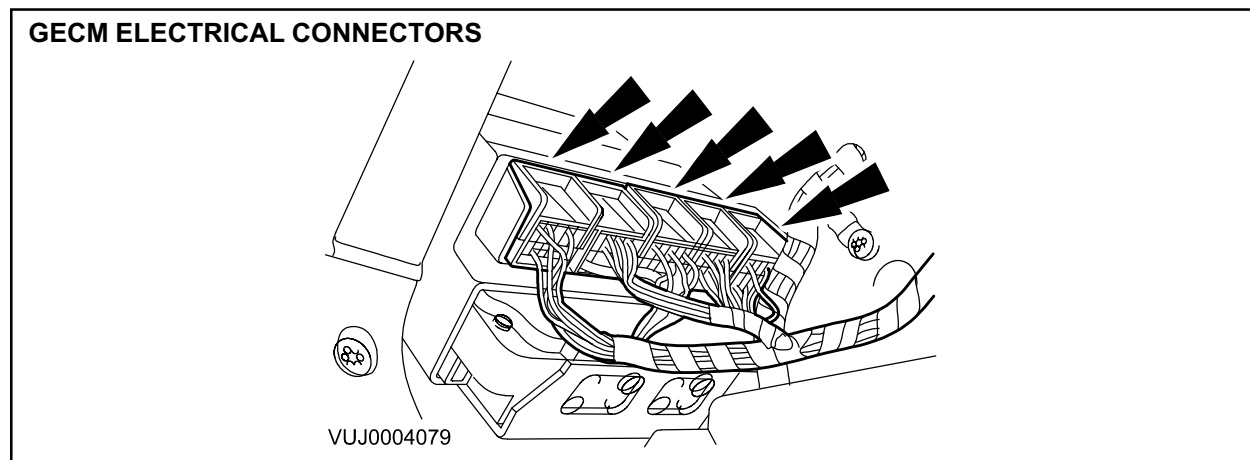
ILLUSTRATION 1

**Note:** The General Electronic Control Module (GECM) is clipped into the Engine Control Module (ECM) bracket above the ECM. There are no separate brackets. The two modules are located on the right side of the passenger compartment beneath the dash near the A-post.

3. Displace electrical connectors from GECM (Illustration 1).
4. Displace and reposition GECM electrical harness.
